**JACKSON COUNTY, MISSOURI  
-- ACQUISITION AND OPERATION EXEMPTION--  
UNION PACIFIC RAILROAD COMPANY**

**SUPPLEMENTAL RESPONSE OF  
JACKSON COUNTY**

## Memorandum

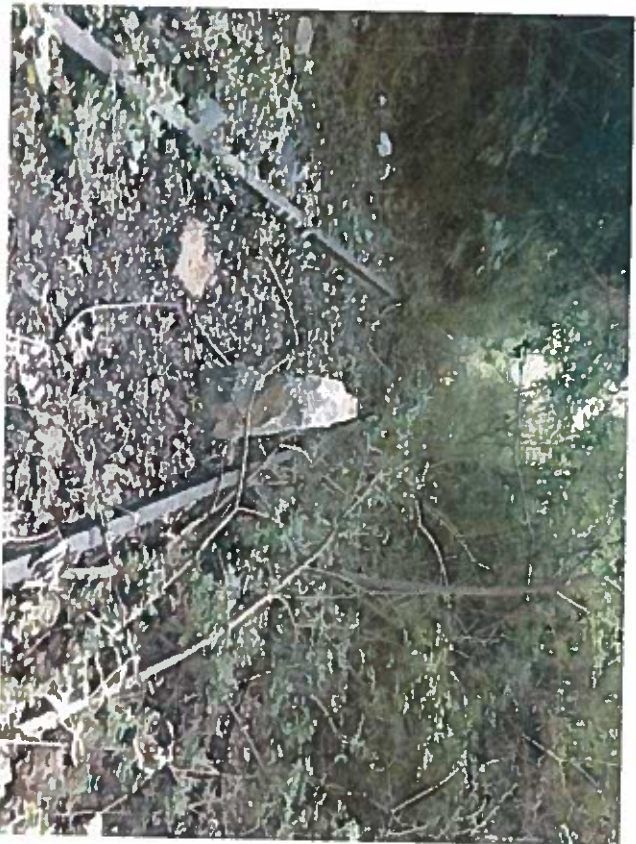
The segment is heavily vegetated with large trees (greater than 6" in dia.) within the track section. At fill locations the edge of shoulder is 11 to 14 feet from centerline of track. In cut sections the ditch is filled in or missing. Within the cut section around station 284+00 rock from the cut above has worked its way down to the track.

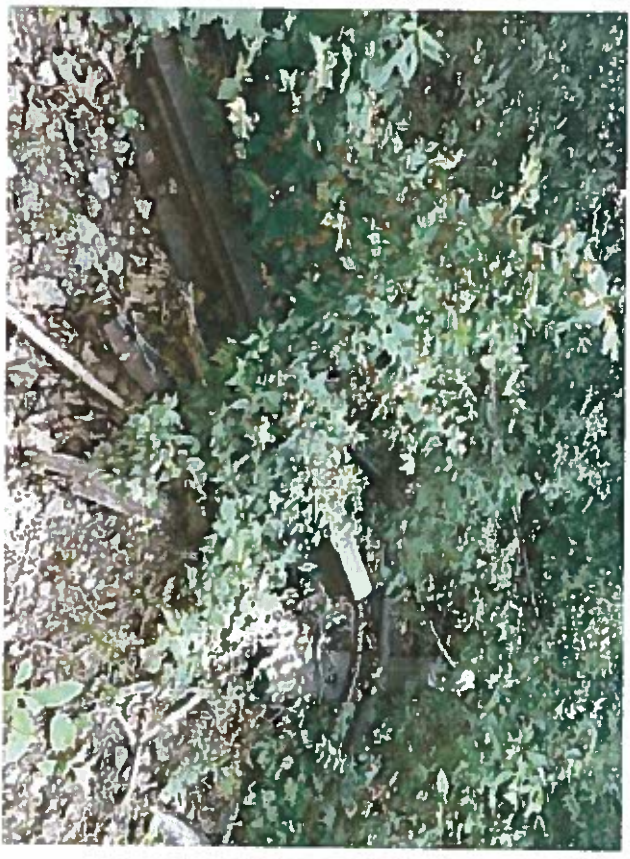
388+00

Track gage ranges from 4'-8 ½" to 4'-11". The crossties are in very poor condition and rail is not attached to the plates or crossties in many locations so the gage varies. The track is cut and missing near station 388+50 and the east rail is missing near station 390+50. The track is buried from station 395+00 to 398+00. The track is covered across 56<sup>th</sup> street, however, the rails are visible in the asphalt.

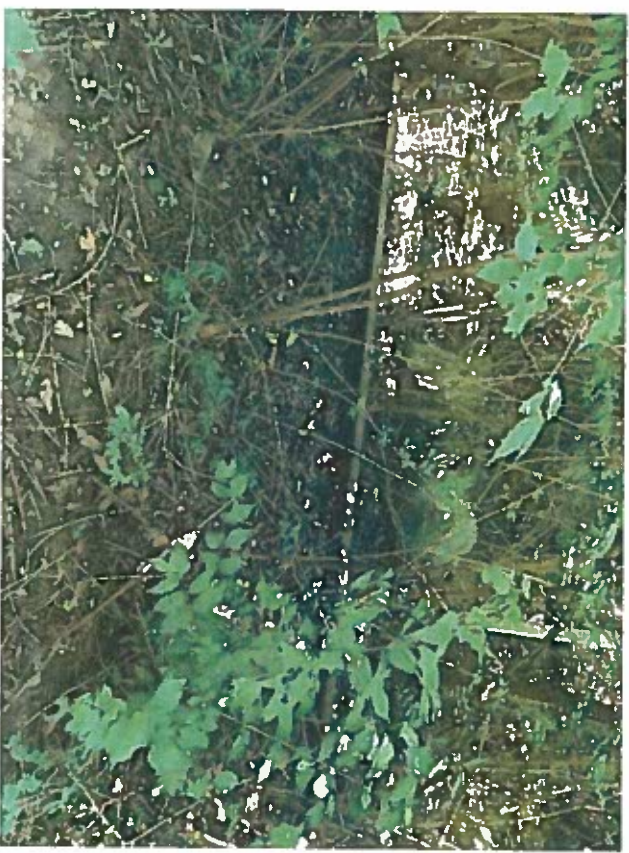
Track gage ranges from 4'-8 ½" to 4'-9 ½". The crossties are in very poor condition and rail is not attached to the plates or crossties in many locations so the gage varies. The track is buried from station 439+00 to 443+00 and 450+00 to 455+00. The track has been removed from Station 455+00 to 460+00.

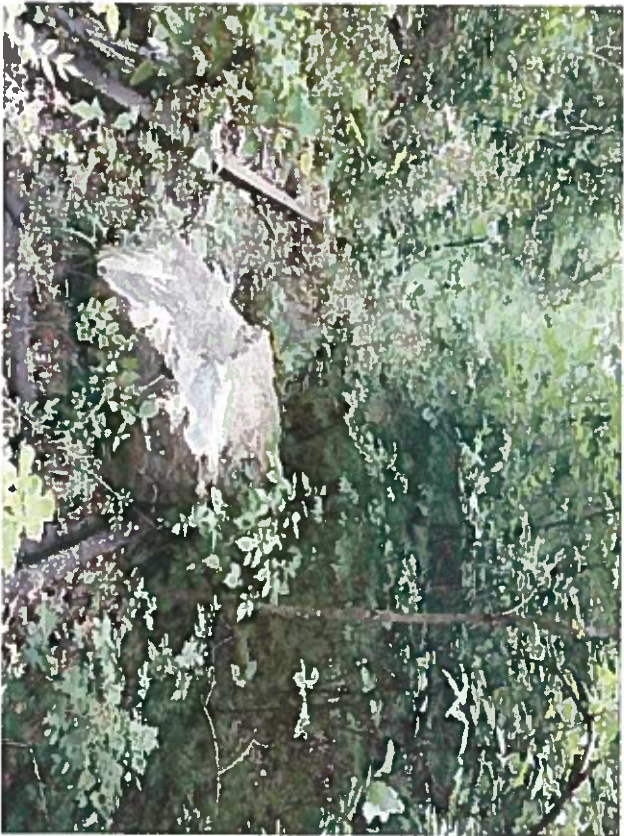
712+00

The segment is heavily vegetated with large trees (greater than 6" in diameter) within the track section. At fill locations the edge of shoulder is 12 to 14 feet from centerline of track. A narrow section exists near station 706+50 where the edge of shoulder is 9 feet from centerline of track. In cut sections the ditch is filled in or missing. A rock cut is located near station 712+00.

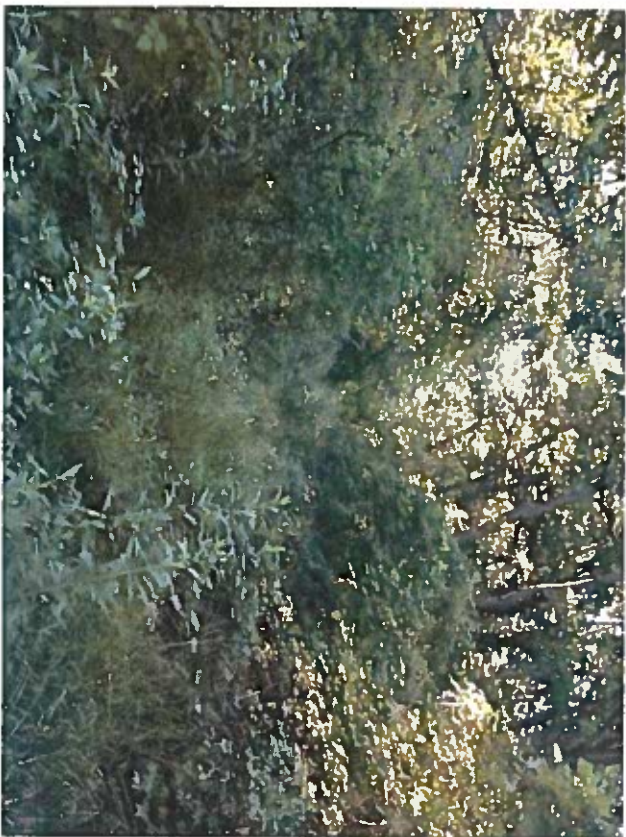
The segment is heavily vegetated with larger trees (greater than 6" in diameter) within the track section. Smaller trees (less than 6" in diameter) were noted at stations 1065+00 to 1075+00 and 1090+00 to Scherer Road. At fill locations the edge of shoulder is 12 to 14 feet from centerline of track. In cut sections the ditch is filled in or missing. Drainage issues were noted at stations 976+00 to 977+00 and 979+00 to 982+00.
